## Terrafix 150 blocks as remedial measure for cut slope failure

In April 2003, The City of Cape Town, Department of Transport, Roads and Stormwater, commissioned Jeffares & Green, a local civil engineering consulting firm, to undertake a geotechnical investigation and propose a design for remedial measures required to stabilise the cut slope failure at Suikerbossie Nek along Victoria Road between Camps Bay and Hout Bay.

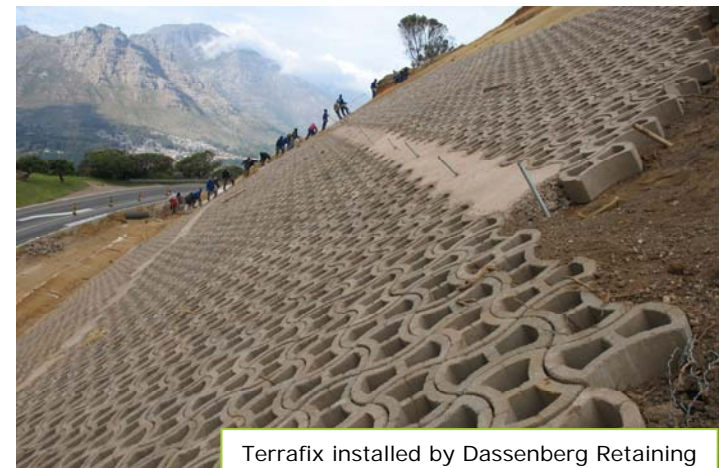
Terrafix installed by Dassenberg Retaining

Van Wieringen explains that Terrafix 150 blocks were selected in order to trap the maximum amount of topsoil on the face thus enabling plant growth, to prevent erosion by surface run-off and to retard the weathering process. "Because of the very large area covered on a curved surface, near-horizontal concrete infill walers were introduced at 5 m intervals to take up the uneven spaces developed between adjacent panels."

"These were anchored to the slope with anchor bars in order to reduce any possible downward sliding force coming to bear on the gabion wall. The maximum density of Terrafix laying pattern (10 blocks per m<sup>2</sup>) was used so as to maintain an interlock between blocks against lateral sliding should support from below be disturbed in any way."

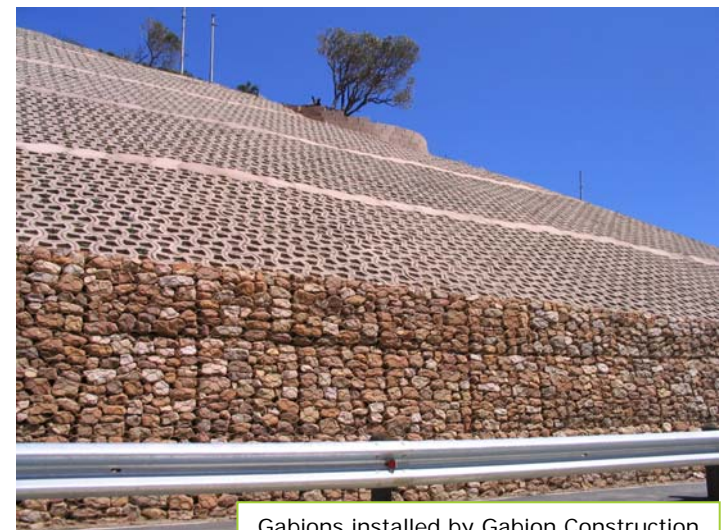
Gabions installed by Gabion Construction

A combination of a near vertical gabion toe wall up to 2,5 m high at the base of the cut, with a 35° Terrafix covered slope above, topped by a concrete-lined cut-off drain, was ultimately selected. The gabions match numerous other gabion structures along Victoria Road and a feature of these particular ones, as developed by Gabion Construction, is the smooth unstepped nature of the face and the top of the wall as it follows the contour of the cut face.
